LBNL 54696

A Systems Approach to Retrofitting Residential HVAC Systems

J.A. McWilliams and I.S. Walker

May 2004

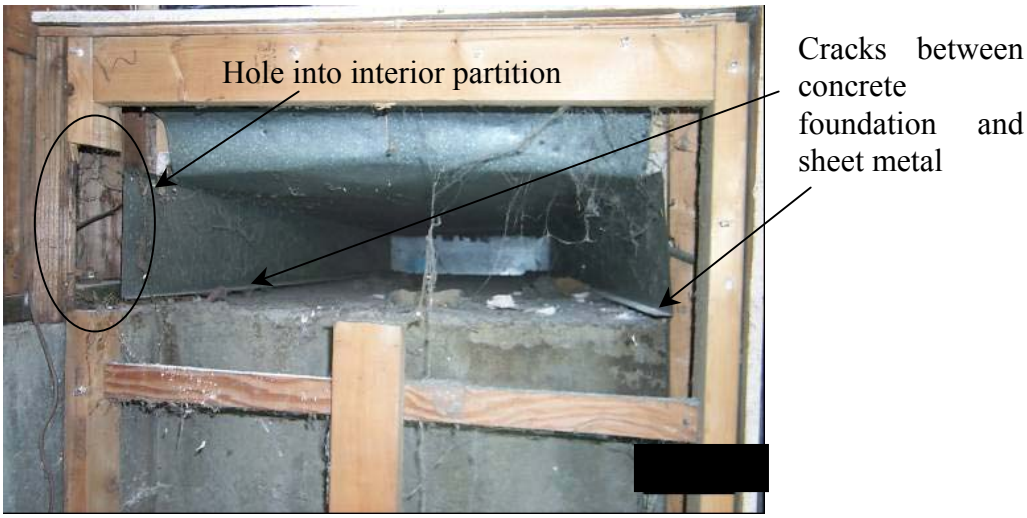
attic, with RSI 4.5 (R-26) glass fiber insulation between the 50 mm by 200 mm (2 by 8 inch joists) on 40 cm (16 inch) centers. The house had the following combination of problems: low-efficiency heating and cooling equipment, leaky (see Figure 1) and poorly insulated ducts (see Figure 2), low air handler flow, low refrigerant charge, and a leaky exterior envelope. In addition, the air handler, furnace, cooling coils and most of the duct system were located outside the conditioned space in the garage and attic. A few major components of the shell leakage were easily identified in this house: several large mechanical chases were open to the attic, and a building cavity return was open to the garage and the attic. The HVAC system was undercharged and operating at only two-thirds of its rated capacity. Lastly, the homeowner reported problems in cooling the upstairs of the house.

Figure 1. Very leaky building cavity return that was removed during the retrofit

The existing return was closed off because it was very leaky and there was no reasonable way to seal it. A larger upstairs return was installed in a new location (upstairs hallway ceiling) to assist in reducing temperature stratification. A second downstairs return was installed in a new location (in the wall at the stairway landing).
