Advanced Duct Sealant Testing

Max H. Sherman and Iain S. Walker
Energy Performance of Buildings Group
Environmental Energy Technologies Division
Lawrence Berkeley National Laboratory
Berkeley, CA 94720

August 2003

What follows is the final report for the Advanced Duct Sealant Testing, 500-010-002, conducted by the Lawrence Berkeley National Laboratory. This report is entitled Advanced Duct Sealing. This project contributes to the Buildings End-Use Energy Efficiency program.

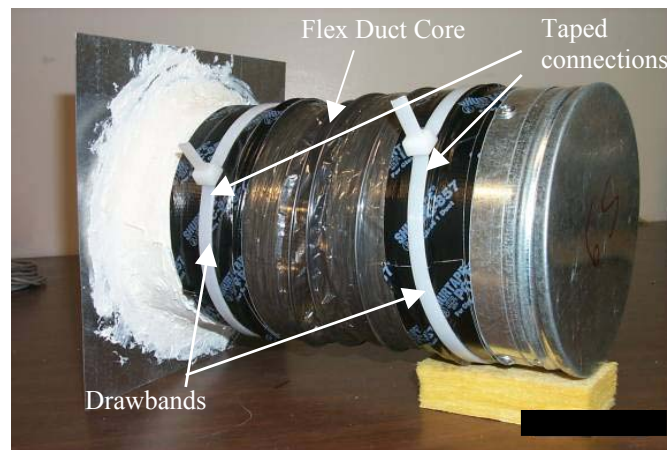
Figure 1 - Example of a core-to-collar test sample showing the two taped connections and the mechanical clamps.

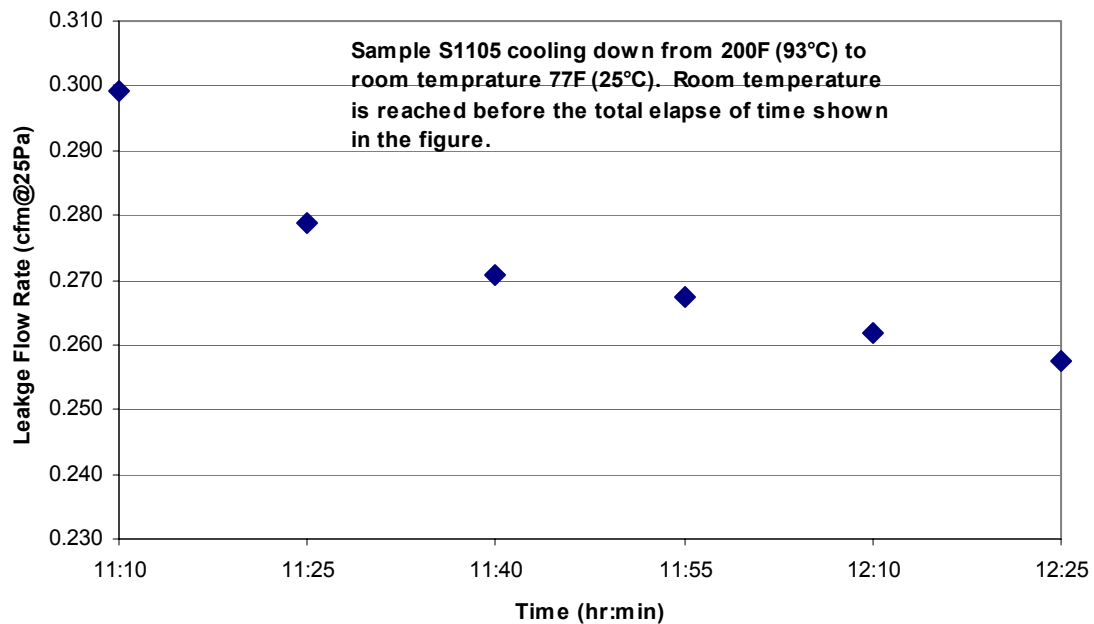
the results. To examine this effect, a specimen was tested six times at 15-minute intervals, with the first measurement taken at its highest temperature (200°F (93°C)). The experiment took place in the laboratory where room temperature is 77°F (25°C). Figure 7 shows the decay in the leakage flow as a function of cool-off time. The leakage flow at the highest temperature is 16% higher than the last value taken 1 hour and 15 minutes later. The difference in leakage is attributed to the "re-sealing" of the joint as it shrinks and hardens at lower temperatures. For consistent results the samples need to cool to room temperature before being leakage tested. Because this effect was not discovered until several months of tested had elapsed, some of these results have additional uncertainty in measured sample leakage.

Figure 7. Decay in the measured leakage as the specimen cools down from 200F (93°C) to room temperature.

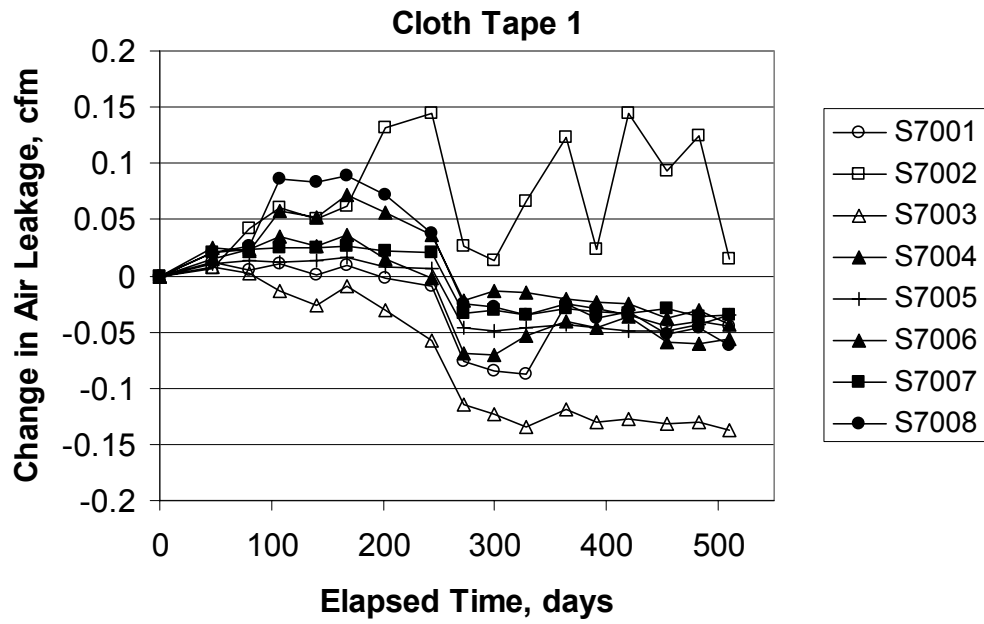
Cloth Tape 1

The leakage results are shown in Figures 15 through 18. From this partial data there are no clear universal trends with both increases and decreases in leakage of different magnitudes for different samples. The cases of decreases in leakage illustrate some of the limitations of our test procedure in terms of the resolution of the leakage tests and other issues, such as the changes due to temperature of the test sample during leakage testing (discussed earlier). For example, for the most recent tests, we waited until the samples were cool before testing, which leads to lower measured leakage. In the earlier measurements we did not consider waiting for temperature stabilization and tested the samples at some intermediate temperature, thus leading to higher measured leakage. The magnitude of the changes in leakage with time and therefore sample temperature shown in Figure 7 indicate that the negative leakage shown in Figures 15 through 18 is of a similar magnitude to this effect. In addition, the visual observations of the core-to-collar joints indicate that that the shrinkage of the duct tape can have a positive effect as it tightens up around the joint, unlike the case of a collar-to-plenum joint where the shrinkage of the duct tape makes it peel off and pull away from the surface it is applied to, thus exposing the leaks.

Figure 15. Change in leakage flow of the flexible core to sheet metal collar joint specimens with cloth tape 1.

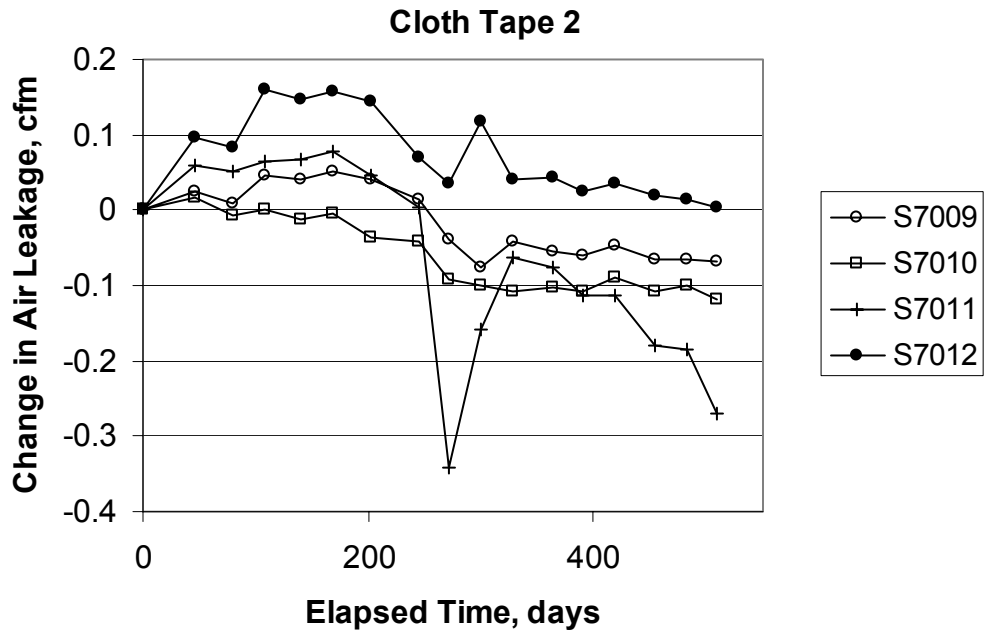
Cloth Tape 2

Figure 16. Change in leakage flow of the flexible core to sheet metal collar joint specimens with cloth tape 2.

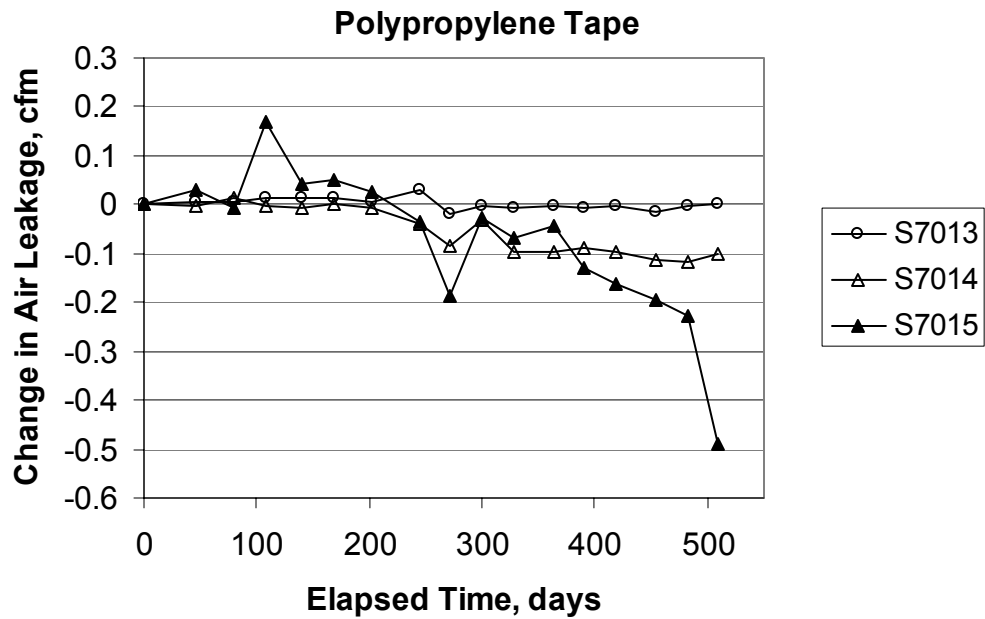
Polypropylene Tape

Figure 17. Change in leakage flow of the flexible core to sheet metal collar joint specimens with polypropylene tape 3.

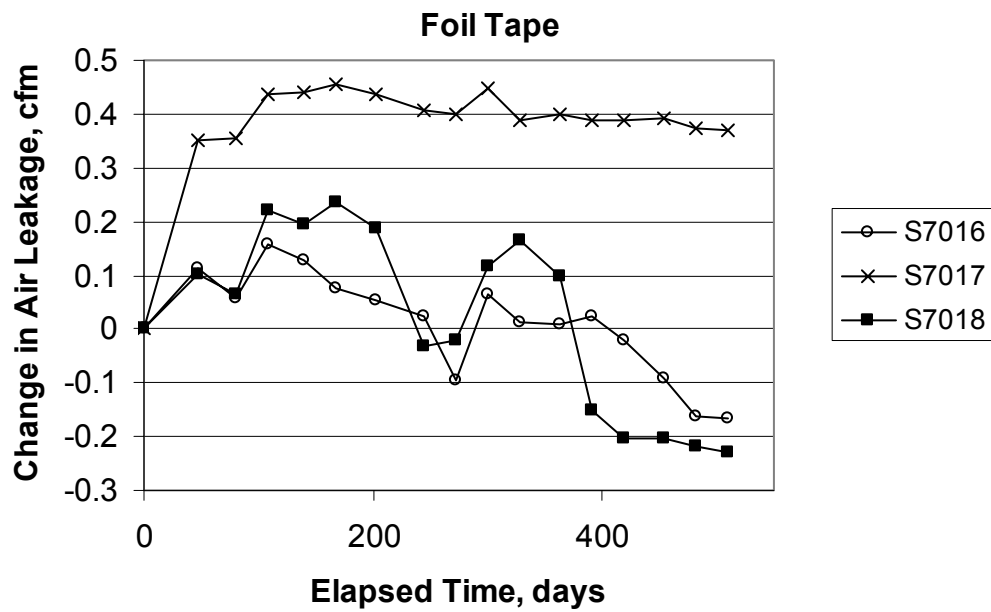
Foil Tape

Figure 18. Change in leakage flow of the flexible core to sheet metal collar joint specimens with foil tape 4.

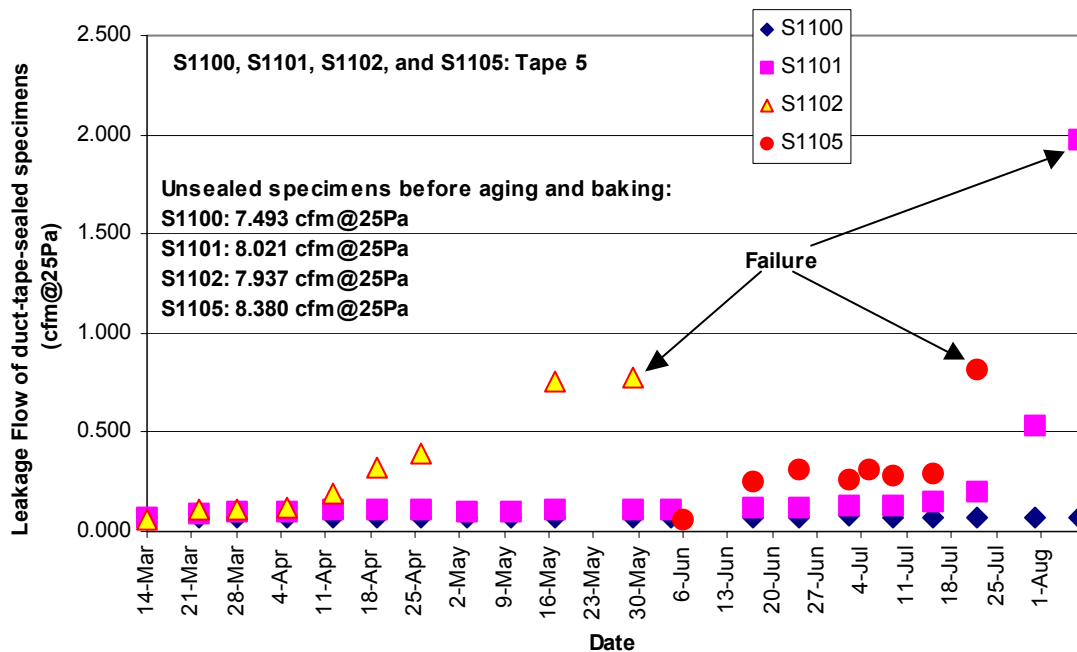
Collar-to-plenum testing was performed for a new duct tape product that has been developed to have improved high temperature performance (Tape 5) as well a sample of Tape 1. The new tape was tested on the collar-to-plenum joint in order to facilitate performance comparisons with previously tested duct sealant products. The old tape (Tape 1) failed in 9 days (using the >10% of unsealed leakage criteria), showing shrinkage and pulling away from the sheet metal plenum. The new tape showed better durability performance failing after about 60 days. Additional tests at lower temperatures showed that the new tape takes longer to fail as temperatures are decreased, and at temperatures below (111°F) 44°C the tape takes more than 100 days to fail (we limited our test duration to 100 days). Figures 19 and 20 show more detailed test results. Because they were mounted in a different location on the test apparatus, these collar-to-plenum were exposed to different temperatures than the core to collar samples. These samples were placed between the left and right chambers (shown in Figure 2) where in previous phases of durability testing the samples experienced cycling temperatures. Table 4 shows the temperatures the specimens were exposed to during the test, and the corresponding elapsed time before failure. Specimen S1102 failed after 2.5 months, and was replaced with specimen S1105. Specimen S1105 appeared to leak at a faster rate at the beginning, then leveled off, then showed a catastrophic (sudden) failure, contrary to the gradual failure of S1002). It took specimen S1105 only one month and three weeks to fail.

Figure 19. The measured leakage of the collar-to-plenum joint Tape-5 specimens.

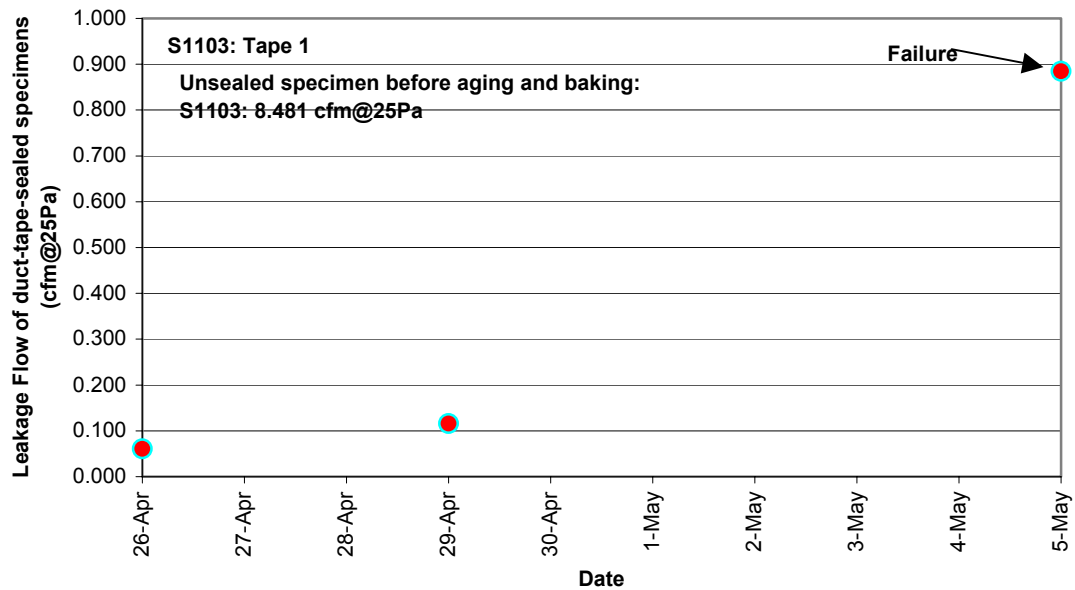
Figure 20. Leakage of the collar-to-plenum joint Tape-1 specimen.
